ROSS POND DAM

NDI I.D. PA-0265

PHASE I INSPECTION REPORT
NATIONAL DAM INSPECTION PROGRAM

D'APPOLONIA CONSULTING ENGINEERS

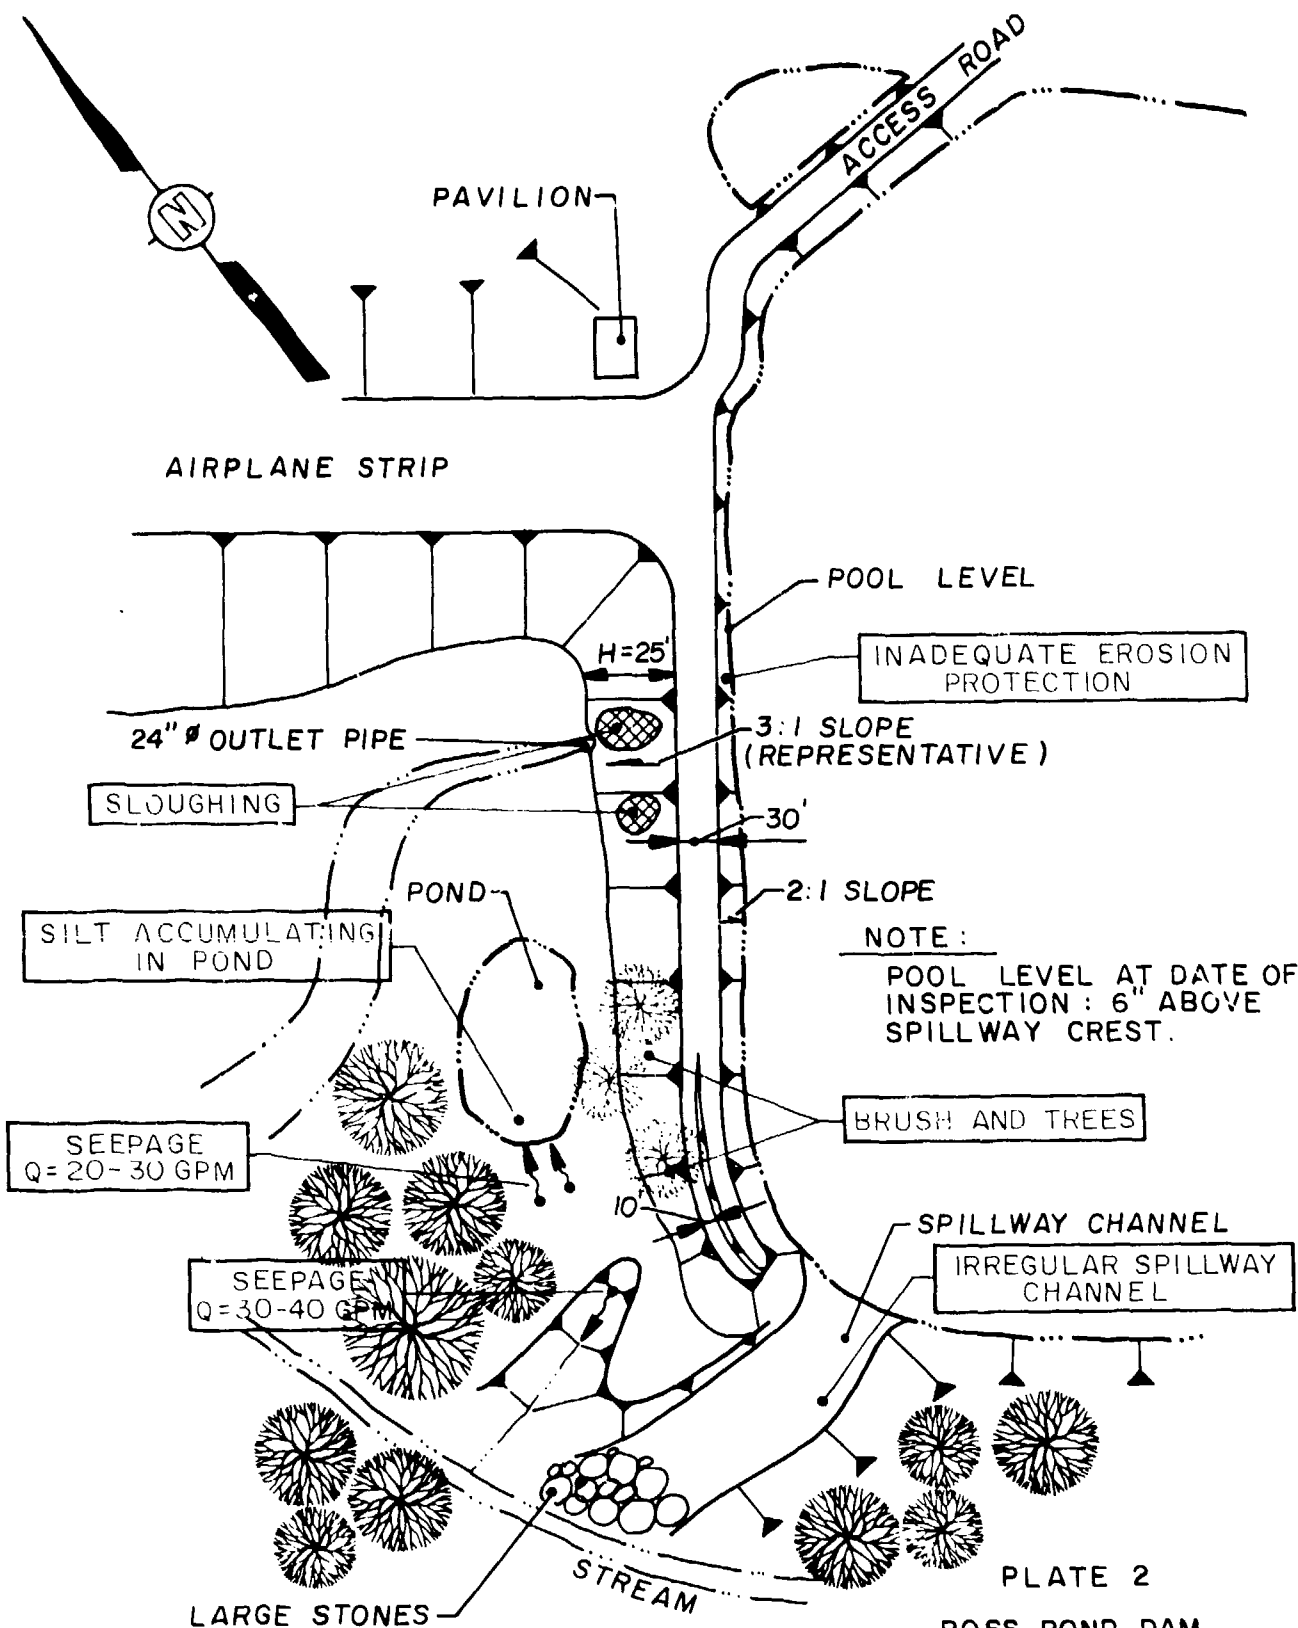
ROSS POND DAM
 GENERAL PLAN
 FIELD INSPECTION NOTES
 FIELD INSPECTION DATE: MAR. 23, 1981

In general, the dam is considered to be in fair condition. The two most notable conditions found at the dam were the presence of a surficial slough on the downstream face at the middle section of the embankment and indications of water seepage through the left half to one-third of the embankment.

A pond covering an area approximately 50 by 100 feet exists below the toe of the dam, left of the center of the embankment. According to the owner, the pond partially existed prior to the construction of the dam. The pond is fed by a spring and/or underseepage through the left abutment emitting approximately 50 feet downstream from the embankment toe. Some seepage discharging into the pond was found to be carrying fines, indicated by the accumulation of silt-like material along the edge of the pond. Total seepage into the pond was estimated to be in the range of 20 to 30 gallons per minute. Another seepage point was found

3.2 Evaluation. In general, the dam was found to be in fair condition. The presence of ponded water along a portion of the embankment toe indicates the possibility of seepage through the dam. The ponded water should be drained and the embankment toe inspected for signs of seepage. The downstream face was irregular and sloughing at sections, raising concern about the continued stability of the dam. A detailed evaluation of the stability of the dam is recommended. Further, the owner is advised to locate the low level outlet valve and regulating mechanism in order to evaluate their present and future working condition. It is also advised that the upstream slope of the dam be provided with erosion protection.

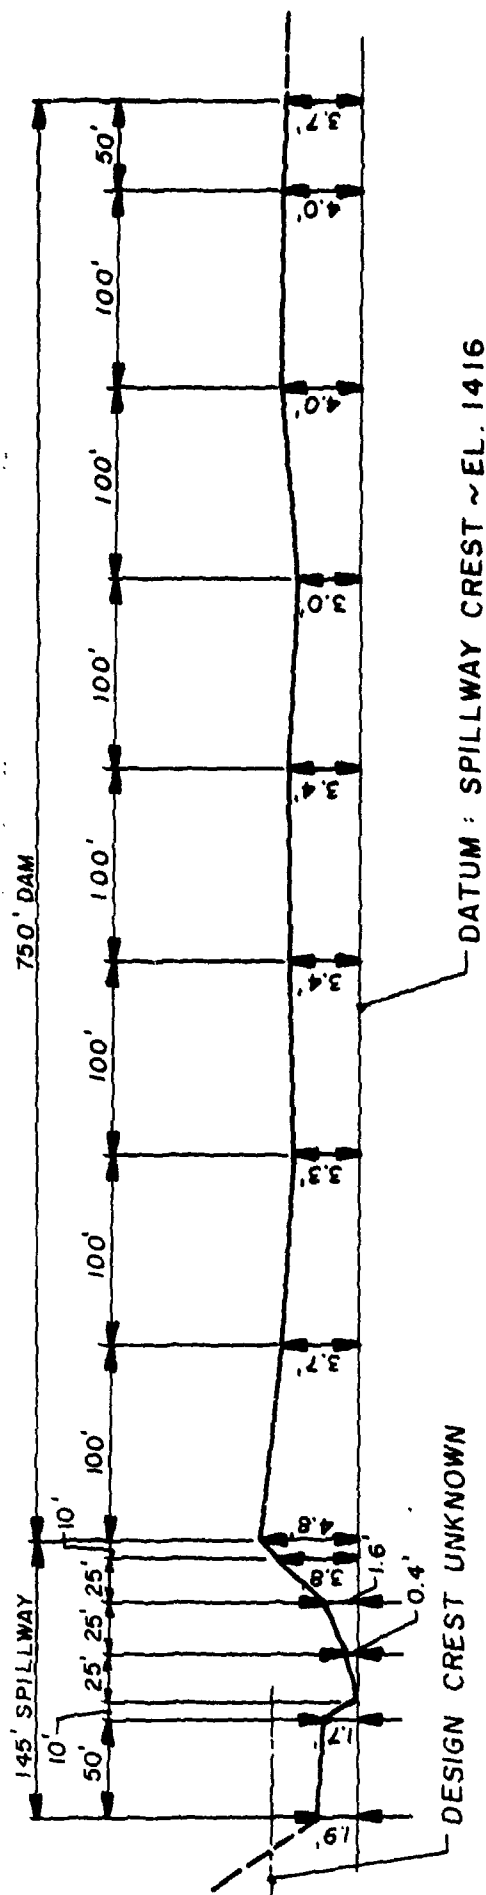
DAM CREST PROFILE (LOOKING DOWNSTREAM)

The crest of the dam was surveyed relative to the spillway crest elevation and was found to have a low spot which provides a freeboard of approximately 3.0 feet above the normal pool level. The measured dam crest profile is illustrated in Plate 3. The downstream embankment slope was surveyed and varies between 3 horizontal to 1 vertical and 2 horizontal to 1 vertical. The upstream embankment slope was measured to be 2 horizontal to 1 vertical. The upstream face is partially protected with riprap. However, no significant shoreline erosion was evident at this time.
